North Clackamas Watersheds 2023 Temperature Study

February 2024

Prepared by Amy van Riessen, NCWC Watershed Restoration Manager
amy@ncwatersheds.org

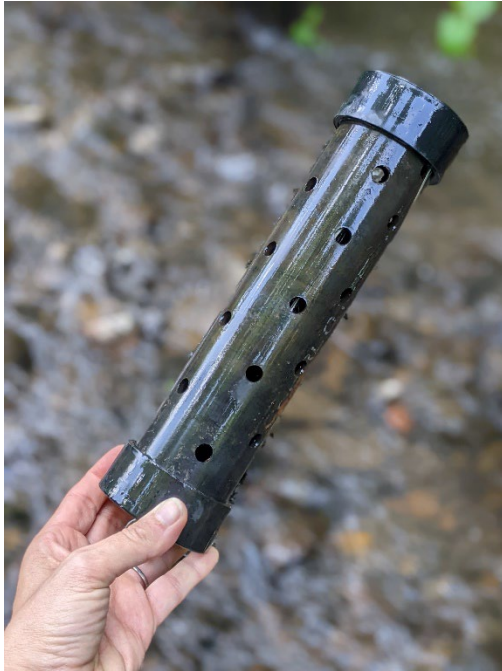
Figure 2 – All temperature loggers are protected in 2" ABS pipes that had 15-20 ¼ inch holes drilled out to allow water to through on a constant basis while preventing potential sediment accumulation around the probe.

At all sites except Site 1, a three-foot piece of rebar was driven into the streambed and was used to secure each thermograph. This rebar was driven to a depth below the surface of the water level, keeping the installation relatively hidden (see Figure 2). At locations that were accessible to the public, the rebar was topped with a plastic cap to prevent people from injuring themselves on it. The probes

were housed in a 2" ABS pipe that had 15-20 ¼ inch holes drilled out to allow water to through on a constant basis while preventing potential sediment accumulation around the probe. Stainless steel cable and clamps then attached the ABS pipe to the rebar to ensure probes were not lost during the sampling period. Once the rebar and pipe were installed, the probe was not noticeable from above the water to prevent tampering. For this reason, photos were taken at every installation location and the sample sites were geo-located utilizing the ArcGIS Field Maps phone app to ensure that the rebar could be found when collecting the probes at the end of the sample season. The installation at Site 1 was slightly different. This logger was installed at the mouth of Kellogg Creek in the fish ladder located at the dam by putting the thermograph in the ABS pipe, affixing that to a 10-pound weight, and then sinking into the fish ladder.

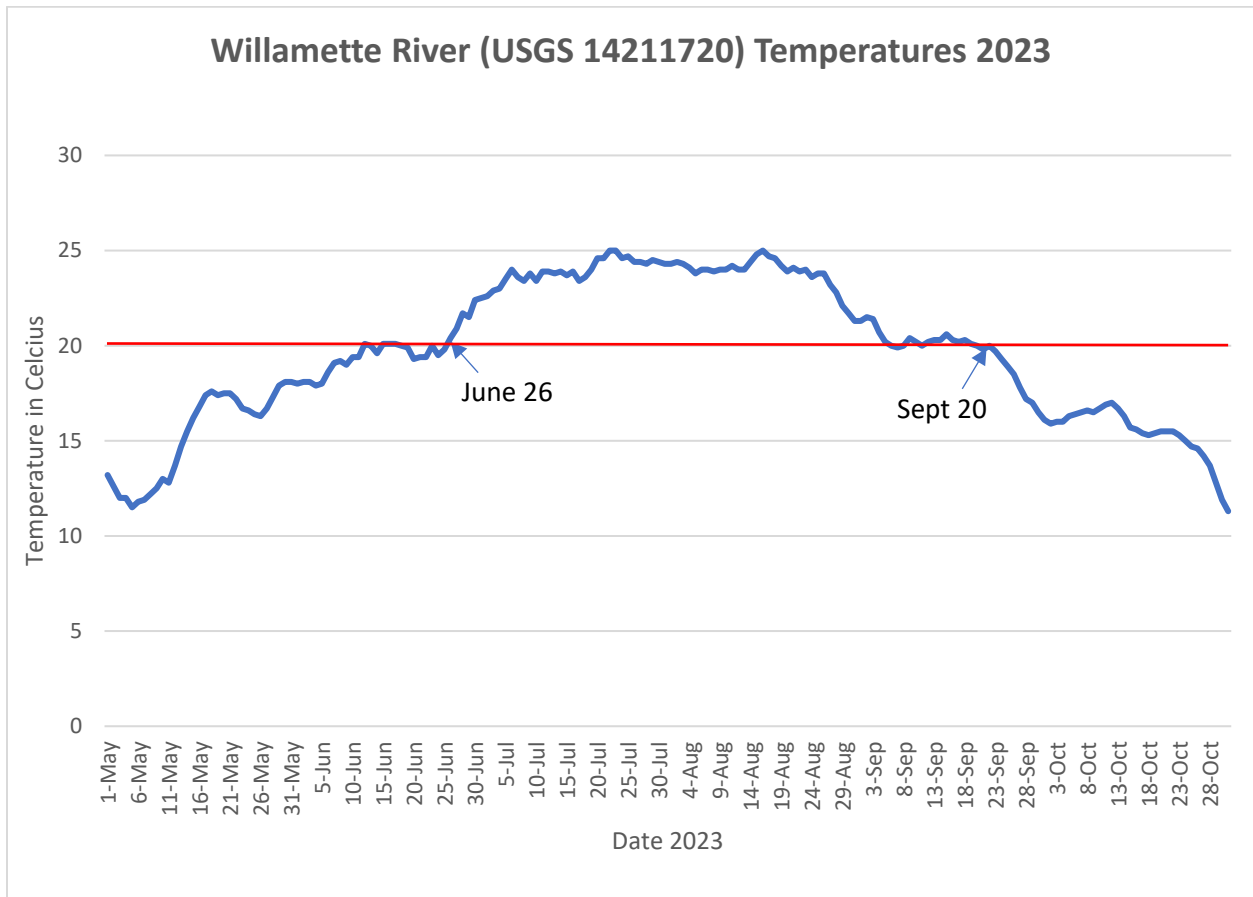
Figure 4 - Summer daily maximum water temperatures in the lower Willamette River at USGS gage station 14211720.

The USGS gaging station for the Willamette River at Portland (USGS 14211720) was used as the reference temperature for the main stem Lower Willamette because the loggers the Council installed in the Willamette River were stolen. This same gage station was also used last year during the temperature study, and during the DEQ 2020 study. In 2023, the lower Willamette River exceeded the DEQ 20°C temperature standard for migration corridors from June 26, 2023 to September 20, 2023, as seen below in Figure 5. The 2012 EPA study identified July and August as the season of concern for quantifying CWR in the lower Willamette River. Our 2022 temperature study (NCWC 2023) concurred with that assessment. However, this year the season of concern extended much further into September. This longer season of high water temperatures should be tracked over time to see how it impacts fish in context of climate change. For consistency we will continue to focus on July and August as the limiting season, however, after five years of data collection we will do an analysis for to look at trends over time. One of the variables that should be looked at closer is the persistence/longevity of the high summer temperatures.

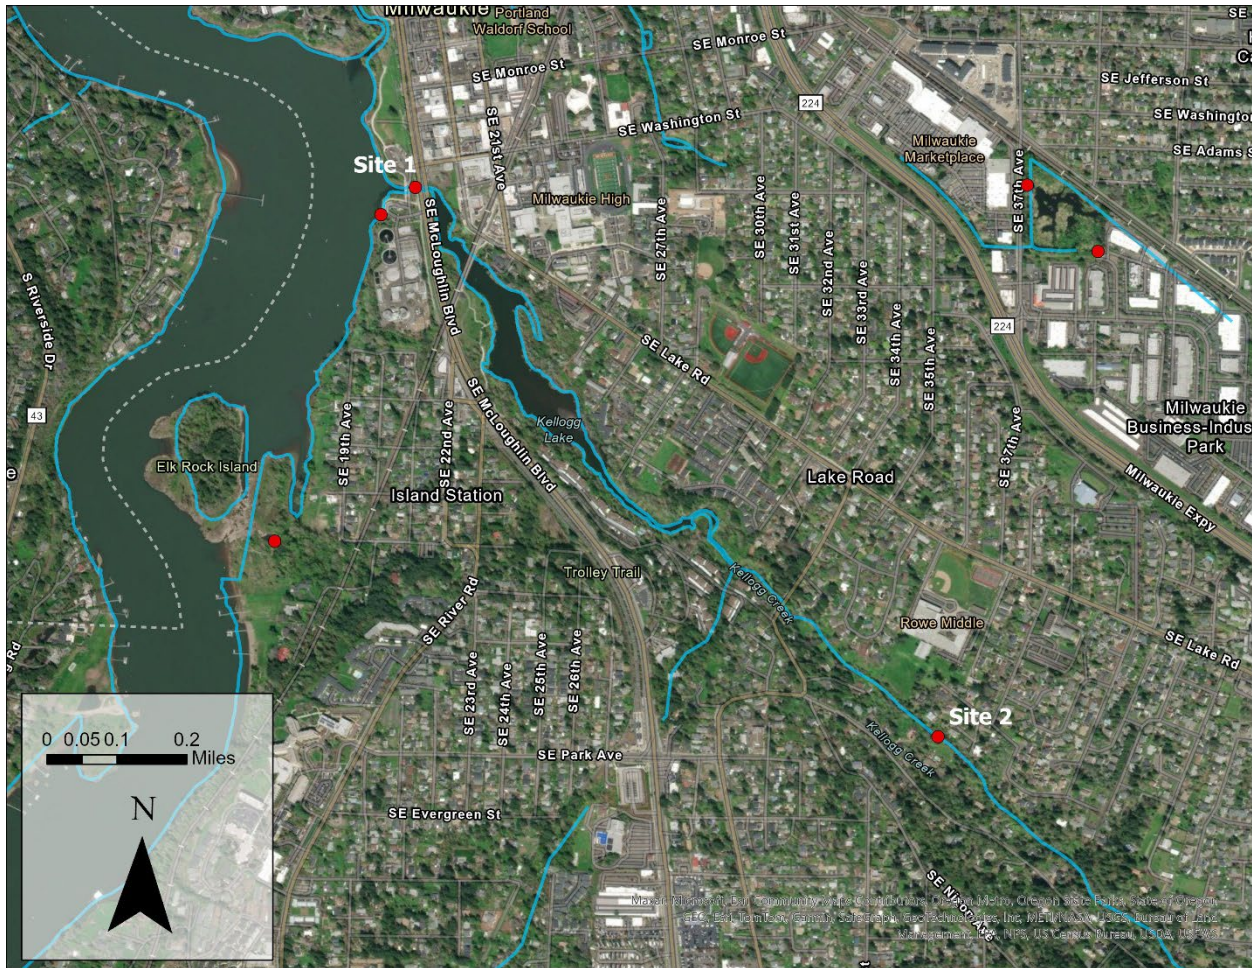
Figure 5 - Location of Kellogg Creek confluence temperature loggers at the Kellogg fish ladder (Site 1) and upstream of the dam impoundment (Site 2).

One temperature logger was installed at the mouth of Kellogg Creek in the fish ladder (Site 1). A second logger was installed on private property upstream of the impoundment behind Kellogg dam (Site 2) to determine how water temperatures were specifically affected by the widened, shallow impoundment formed behind the dam. Unfortunately, the Site 2 logger died and stopped recording data on September 6th. For this reason, we could only summarize the data for July and August of 2023.

During DEQ's CWR study (DEQ, 2020) Kellogg Creek was identified as a coldwater refuge during the summer months. However, the temperature data collected at Kellogg's mouth and upstream of the dam's impoundment show that the potential of Kellogg's confluence to provide CWR is not only impacted by the dam which prevents fish access into the creek, but the impoundment behind the dam is significantly increasing water temperatures to levels similar to the Willamette mainstem.

When comparing daily maximum temperatures in Kellogg Creek versus the Lower Willamette, we found that on average the daily maximums were actually higher in the Kellogg fish ladder in than in the Willamette mainstem for the months of July and August by 0.6 °C (see Table 3). However, we know that the dam's impoundment is wide and shallow and probably affects the water temperature through that

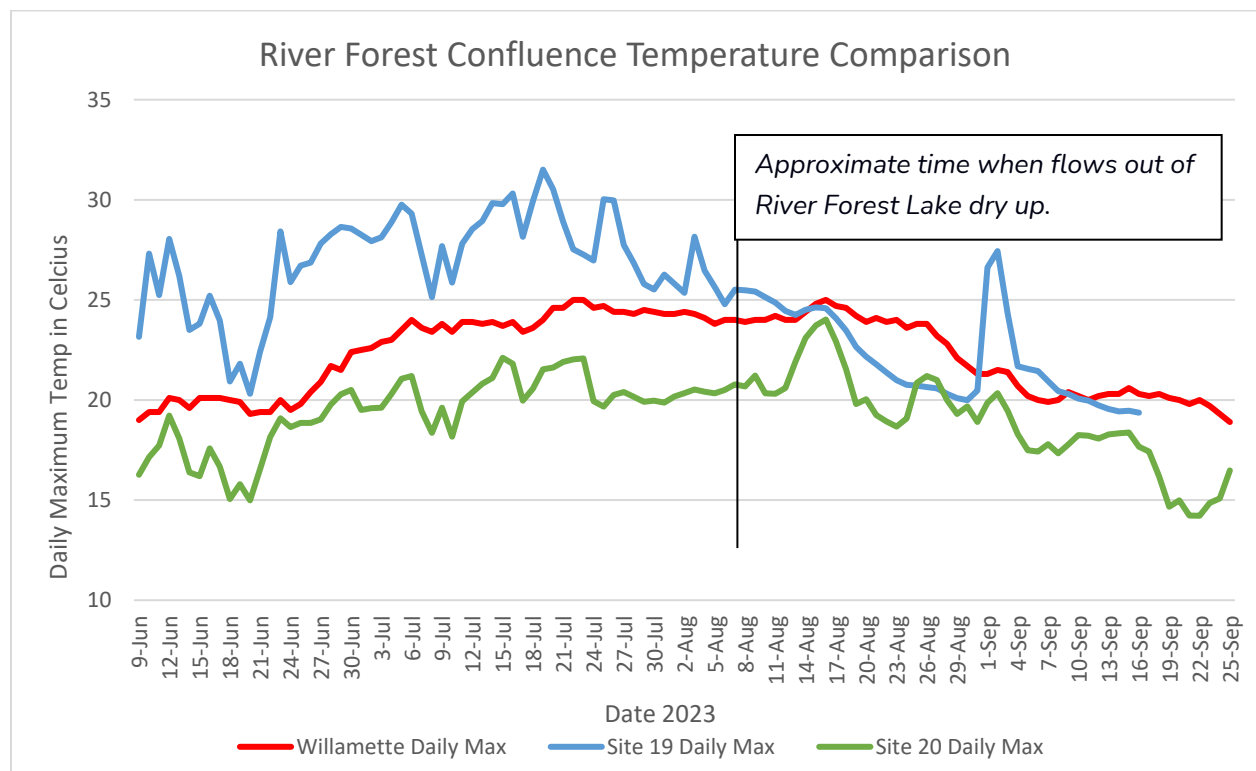
Figure 9 - Average daily maximum temperatures of River Forest Creek as compared with lower Willamette River temperatures.

Summer water temperatures found at the mouth of River Forest Creek were higher than the Lower Willamette River as a result of the high temperature water flowing out of River Forest Lake. In July when water is flowing out of the lake, there is a 7.9 C temperature difference between the two sites (see Table 4). Thankfully, flows out of the lake are very low in the summer months and the creek dried up at the confluence downstream of the culvert in August as a result of silt settling at the inlet of the

This data shows that River Forest Creek has the potential to function as CWR habitat if the channel could be disconnected from River Forest Lake. This also supports the findings of the Council’s 2022 Watershed Action Plan, which recommends the disconnection of the River Forest Creek channel from the River Forest Lake impoundment as a priority action. Because the lake is not an in-line impoundment, it’s disconnection from the creek may be possible, and further study should be conducted to determine its feasibility. NCWC is also planning to construct a habitat enhancement project at the confluence that will go to construction this Summer 2024. This project will target winter and spring rearing habitat in the Willamette River as we know River Forest Creek dries up in the summer.

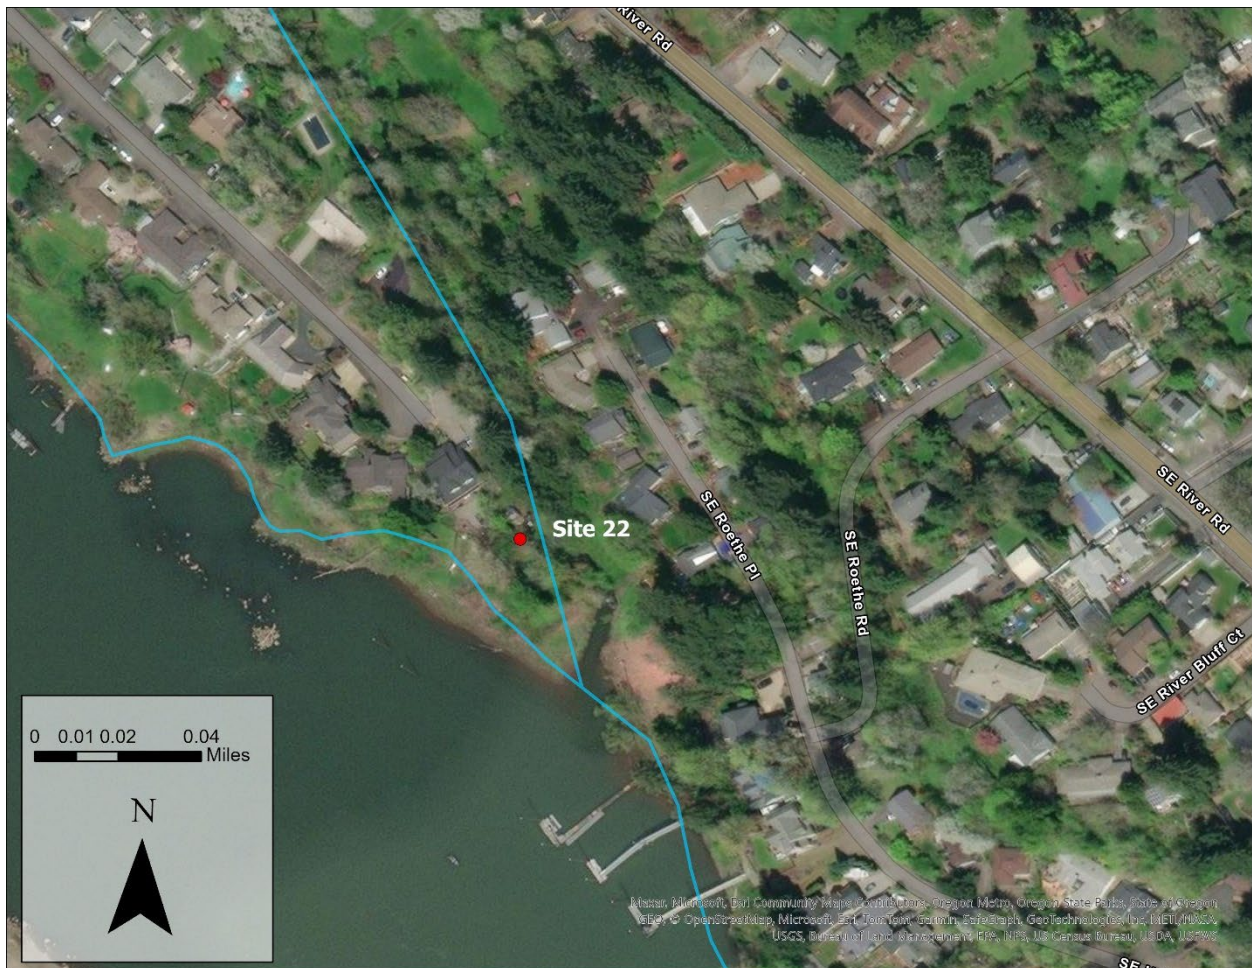
Figure 10 - Location of Boardman Creek confluence temperature loggers.

There was one logger installed at the confluence of Boardman Creek with the Willamette River. Site 22 was at the Oak Lodge pump station and the site was selected because the temperatures there are not influenced by the backwater effects of the lower Willamette River.

Summer water temperatures at the Boardman Creek confluence were significantly cooler than the Willamette, and the average daily maximum temperature for the months of July and August was 3.4 °C lower than at Site 22 (see Table 5).

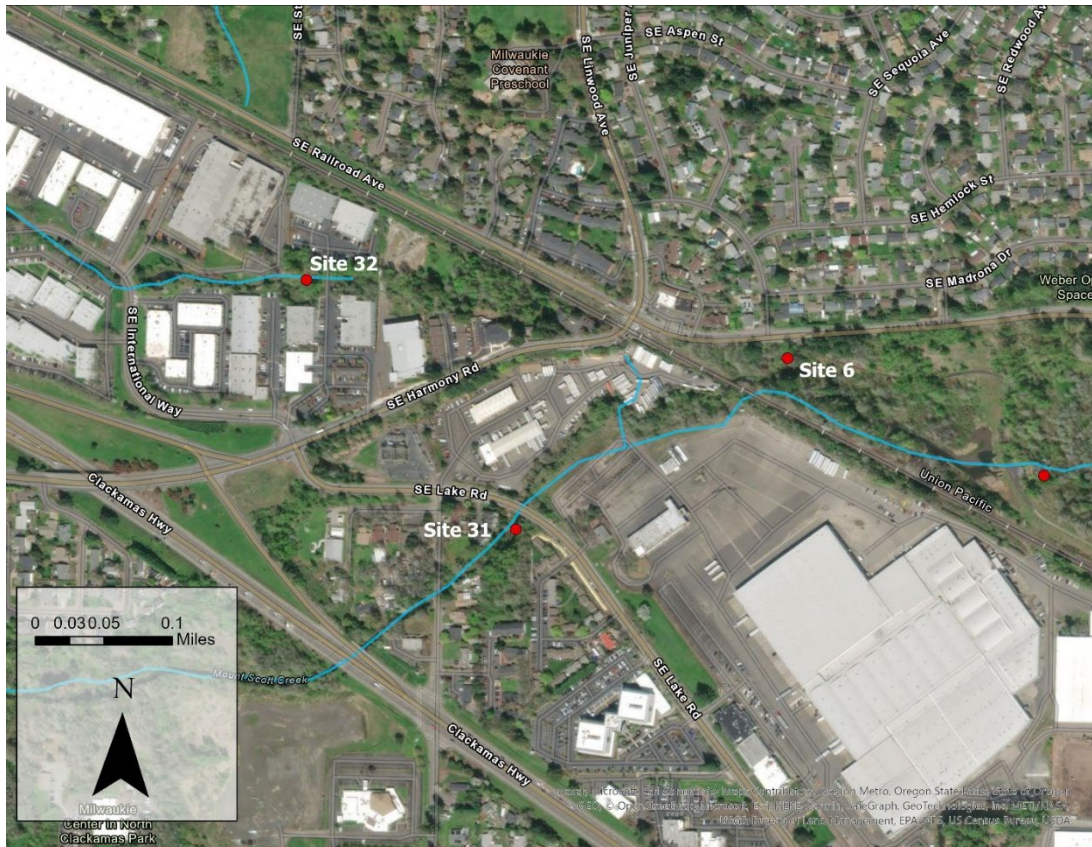
Figure 14 - Location of Minthorn-Mt. Scott Creeks confluence temperature loggers.

- Site 31 - downstream of the confluence of Minthorn with Mt. Scott
- Site 32 - Minthorn Creek upstream of the confluence
- Site 6 - Mt. Scott Creek upstream of the confluence.

The average 7dAM in July and August was 1.4 °C warmer in Minthorn Creek (Site 32) than Mt. Scott Creek (Site 6):

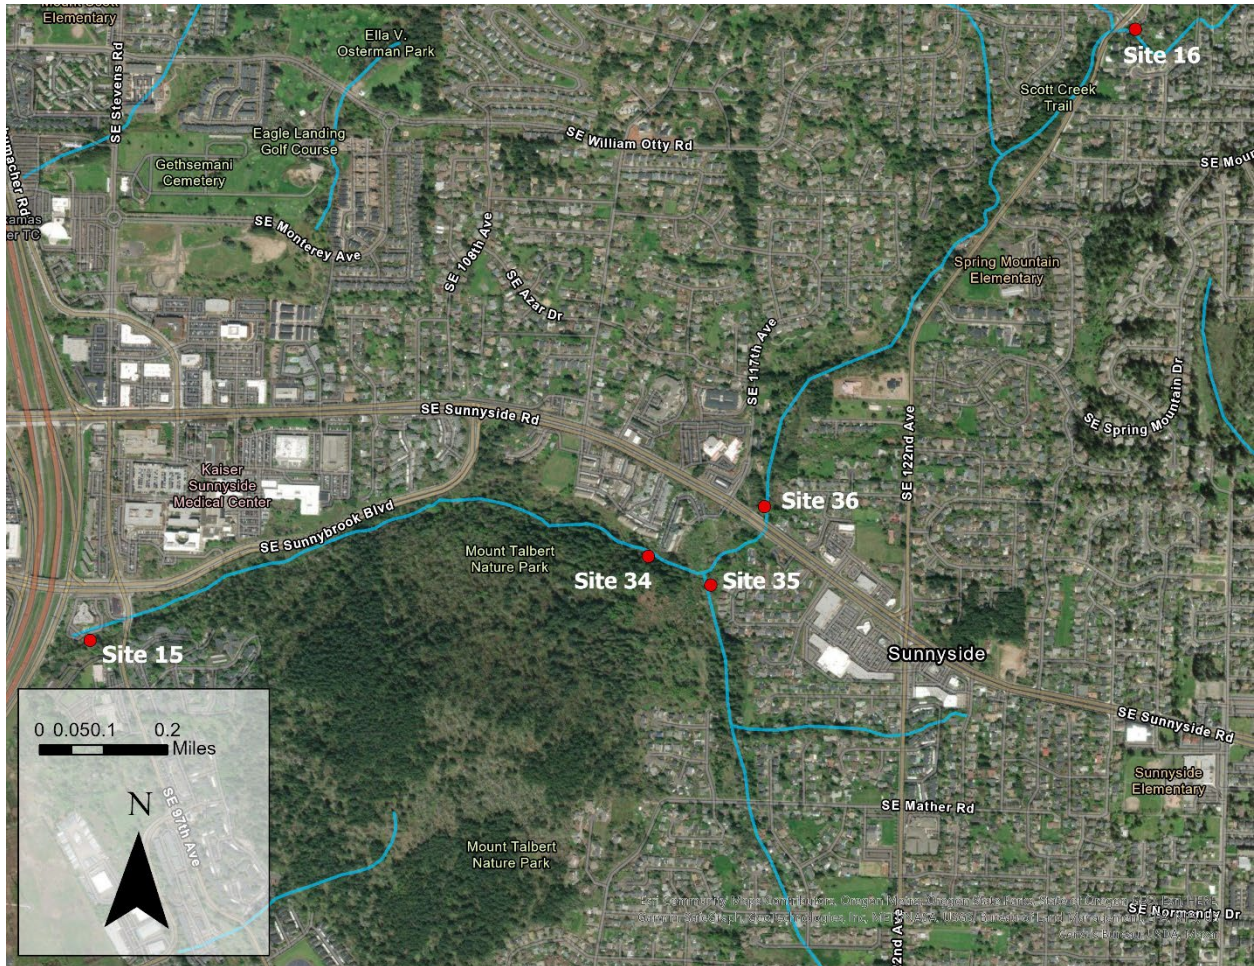
Figure 18 - Location of Mt. Scott Creek temperature loggers near an unnamed tributary in Mt. Talbert Nature Park.

This tributary was chosen as a study site because during last year’s temperature monitoring (NCWC, 2023) we found significantly warming in Mt. Scott Creek through the Sunnyside corridor. Unfortunately, the logger at Site 34 was stolen and the data was unrecoverable from the logger at Site 36. However, we still analyzed the data at Site 35 and compared it with the temperatures at Site 15 and Site 16 to see if the unnamed tributary is contributing significantly hotter or cooler water. Site 15 and Site 16 are each approximately one mile from the confluence of the unnamed tributary, so we are just looking for any significant anomalies.

Although Site 35 is a distance from Site 15 and 16, the tributary temperatures appear to be in the expected range. There were not significant cold or warm water coming from that drain, and water temperatures were actually cooler than those found at Site 15. However, because of the loss of the thermographs directly up and downstream of this tributary, the temperature study at this site should be repeated in 2024. It should be noted in Figure 19 that we once again saw a dramatic increase in water temperatures between Site 16 and Site 15, with an average increase of 3.4 C in the summer months (July-August).

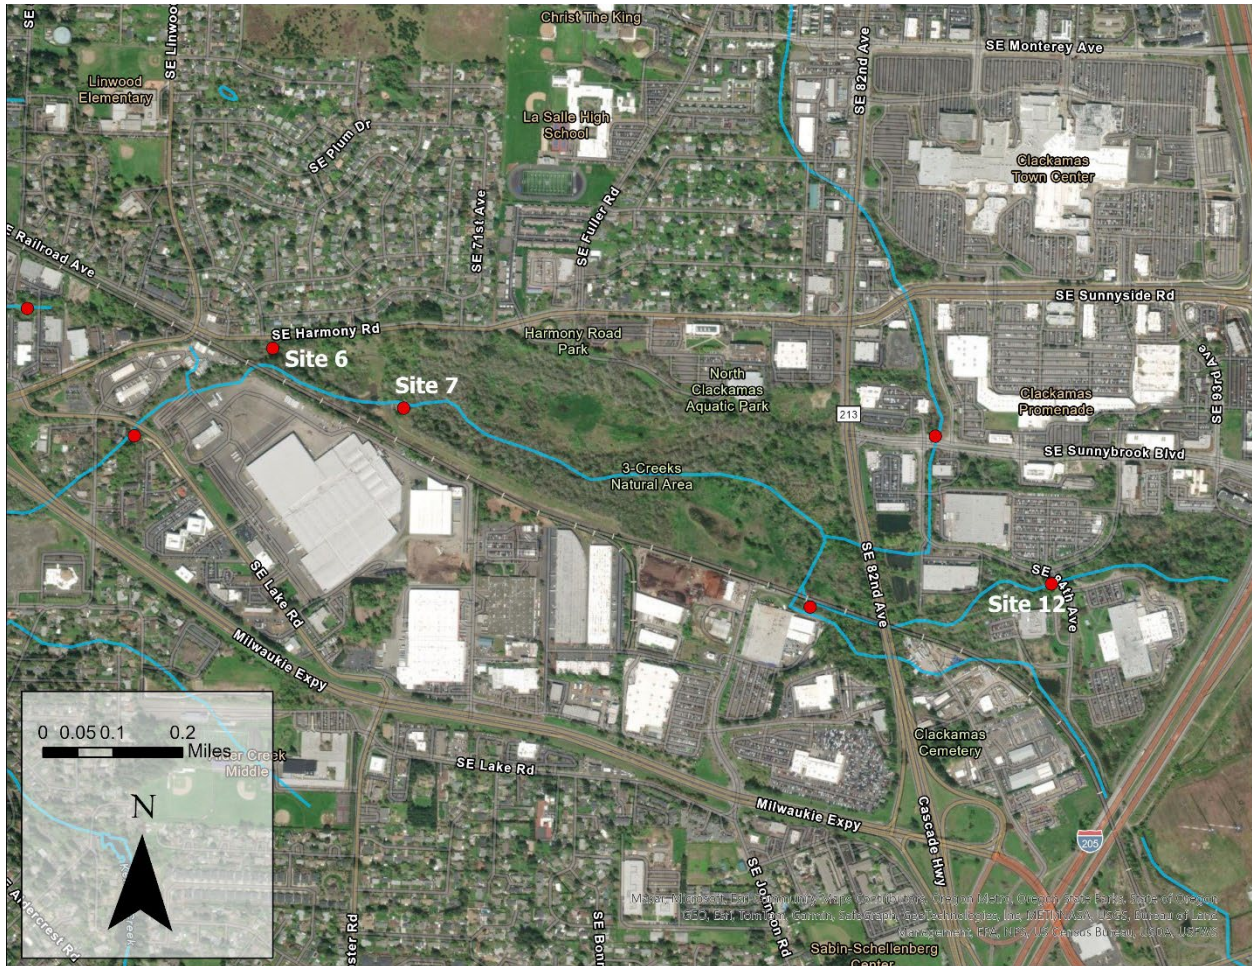
Figure 20 - Location of 3-Creeks Natural Area temperature loggers.

The 3-Creeks Natural Area is approximately 89 acres of streams, wetlands, and upland habitat that encompasses Mt. Scott Creek and its confluences with Phillips and Dean Creeks. The site is wedged between industrial and commercial properties, a set of active railroad tracks, and private homes. The site is also owned by Clackamas Water Environment Services (WES) and is home to a flood control facility which stores water during the heaviest rains to protect businesses and infrastructure. There were two thermographs installed in 3-Creeks Natural Area and one just upstream at Site 12. The temperature study of the confluences of Phillips Creek and Dean Creek with Mt. Scott Creek is discussed in the previous section, and shows how those two tributaries contributed colder water to the Mt. Scott mainstem.

As discussed in the tributary study previously, when we compare those upstream temperatures coming into 3 Creeks (Site 12) with the temperatures collected downstream at Site 7 we saw a drop in water temperatures related to the cooler flows coming out of Phillips and Dean. The 3-Creeks Natural Area contains some good riparian canopy, however the channel is significantly incised preventing the creek to flow out into the floodplain and allowing for the cooler late season hyporheic flow. WES is currently designing a restoration project that will allow for the creek to interact with the floodplain more, and it will be interesting to see how that affects summer temperatures.

Between Site 7 and Site 6 we did see a 1.5 °C increase in the average 7dAM in the months of July and August.

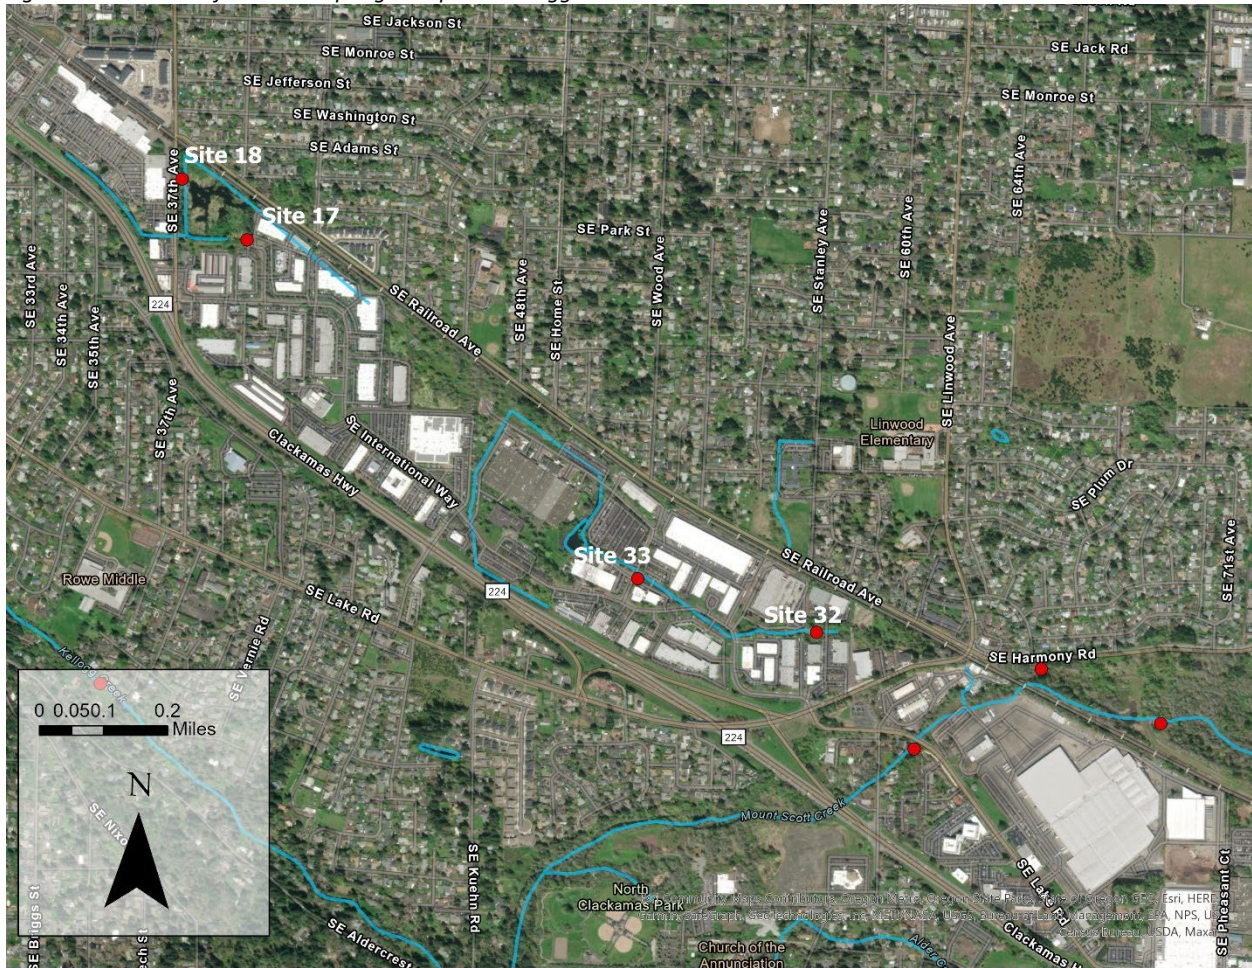
Figure 22 - Location of Minthorn Springs temperature loggers.

The Wetlands Conservancy Urban Wetlands State-of-the-Catchments Summary (Labbe and Scully-Engelmeyer, 2016) noted that the water quality in Minthorn Springs Wetland is considered poor. For this investigation, we assessed the difference between water temperatures coming directly out of the spring seep at the inlet of the wetland (Site 18), versus water temperatures exiting the wetlands into Minthorn Creek (Site 17). Then we assessed how the water temperatures changed as flows came down Minthorn Creek into Site 33 and 32. The location of these four temperature loggers can be seen below.

The logger at Site 33 failed on August 6, 2023, but Onset was able to recover the data up to that point. The logger at Site 32 was out of water on off from August 13 onwards, so that data was removed from the dataset. Not surprisingly, the water temperatures coming out of Minthorn Springs wetland warm up as the creek winds through the International Way industrial park. The creek through this area has very little shade and a lot of impervious surfaces adjacent to it.

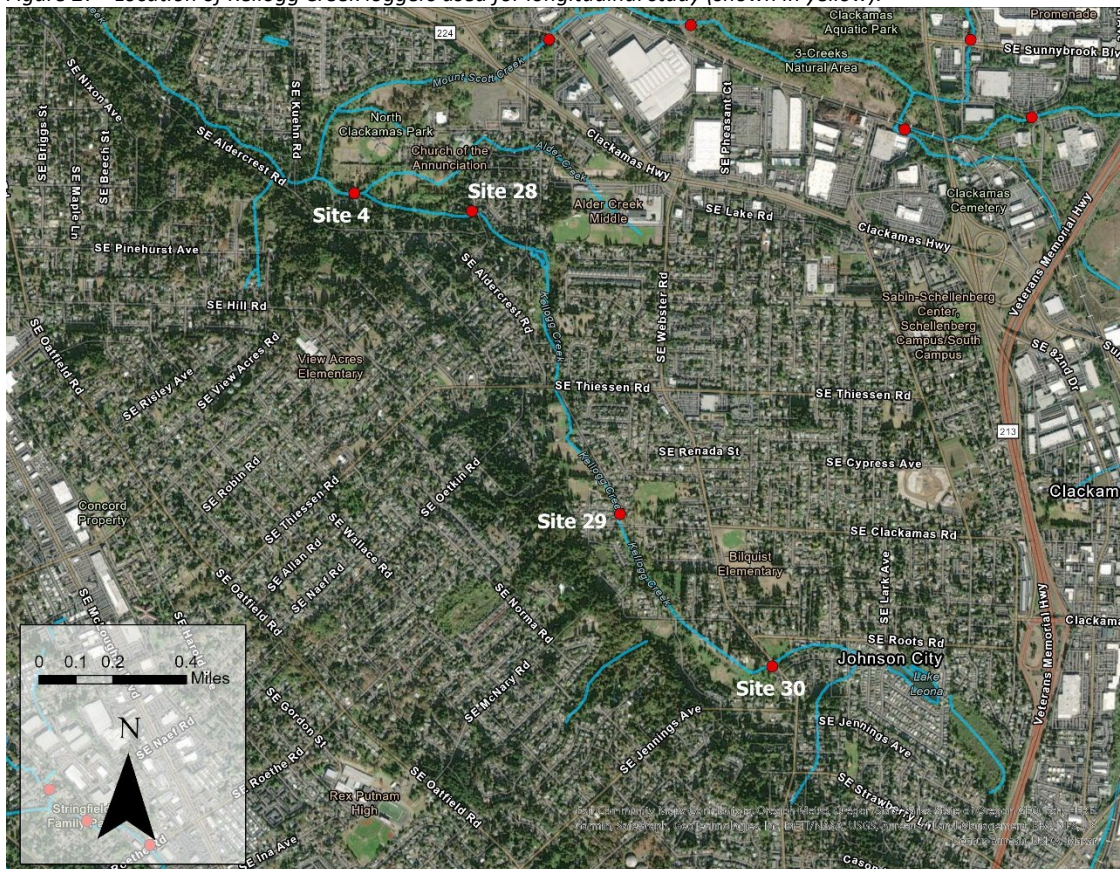
Figure 27 - Location of Kellogg Creek loggers used for longitudinal study (shown in yellow).

- Site 4 – Kellogg Creek above confluence (private property)
- Site 28 – Kellogg Creek at SE Rusk Road
- Site 29 – Kellogg Creek at SE Clackamas Road
- Site 30 – Kellogg Creek at SE Webster Road

The cooler water seen coming from Kellogg Creek in 2022, was evident this year at both Site 4 and 28. These two sites are located downstream of Parmenter Wetland, a beaver wetland that appears to be fed by Lovawalla Spring. Parmenter Wetland also has good connectivity to the floodplain, allowing for floodplain storage in the wet season and increased cool water availability in the summer. Further study should look at Parmenter Wetland to confirm that it is the source of cool water that we see between Site 28 and 29. The wetland would be a good candidate for imagery using the infrared drone.

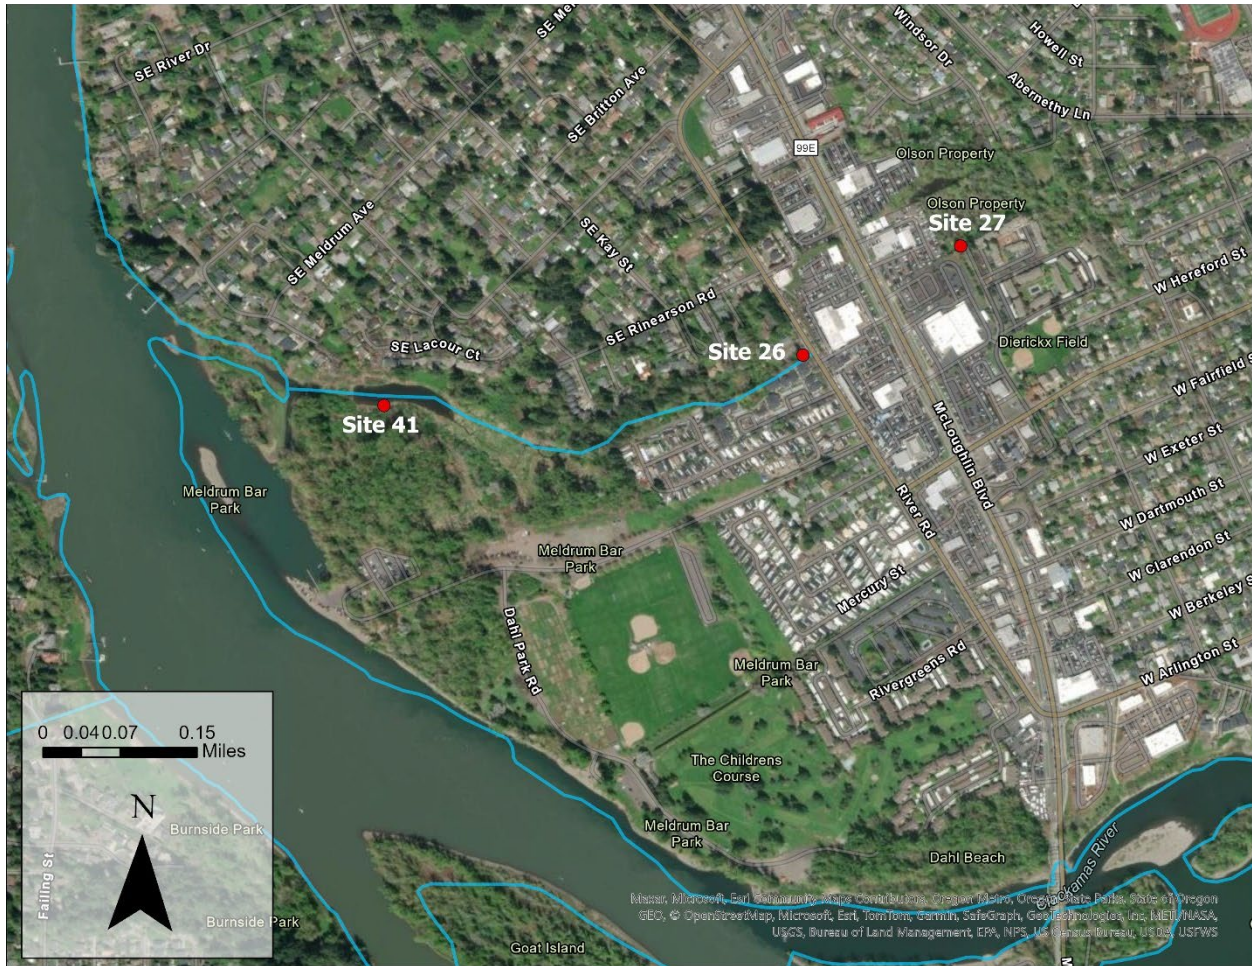
Figure 29 - Location of Rinearson Creek temperature loggers.

Temperature loggers were installed in Rinearson Creek in three locations. Site 41 was a new monitoring location in the pond located at the Rinearson mitigation site. Site 26 was located on the west side of River Road and Site 27 was located upstream adjacent to Olsen Wetlands (see Figure 29).

In 2022 we saw a significant temperature increase as water flowed from Site 27 to Site 26 (NCWC, 2023). We did not see that heating through the McLoughlin corridor this year, and in fact the average summer 7dAM (July-August) decreased 3.4 °C between these sites. This shows the importance of collecting multiple years of data over successive years.

- Average 7dAM at Site 41 (July – August) = 24.4 °C
- Average 7dAM at Site 26 (July – August) = 18.0 °C
- Average 7dAM at Site 27 (July – August) = 21.4 °C

We also saw significant warming between Site 26 and Site 41, with an increase of average summer 7dAM (July-August) of 6.4 °C. This increase in temperature is probably due to the large beaver pond at this mitigation site. This result is also consistent with what was found in the Rinearson Natural Area Restoration Year 5 (2023) Monitoring Draft Report (Waterways Consulting, Inc, 2023). That report showed that the pond temperatures increased significantly over those recorded just upstream in the emergent marsh. This site may also be a good candidate for imagery collection utilizing the infrared drone.

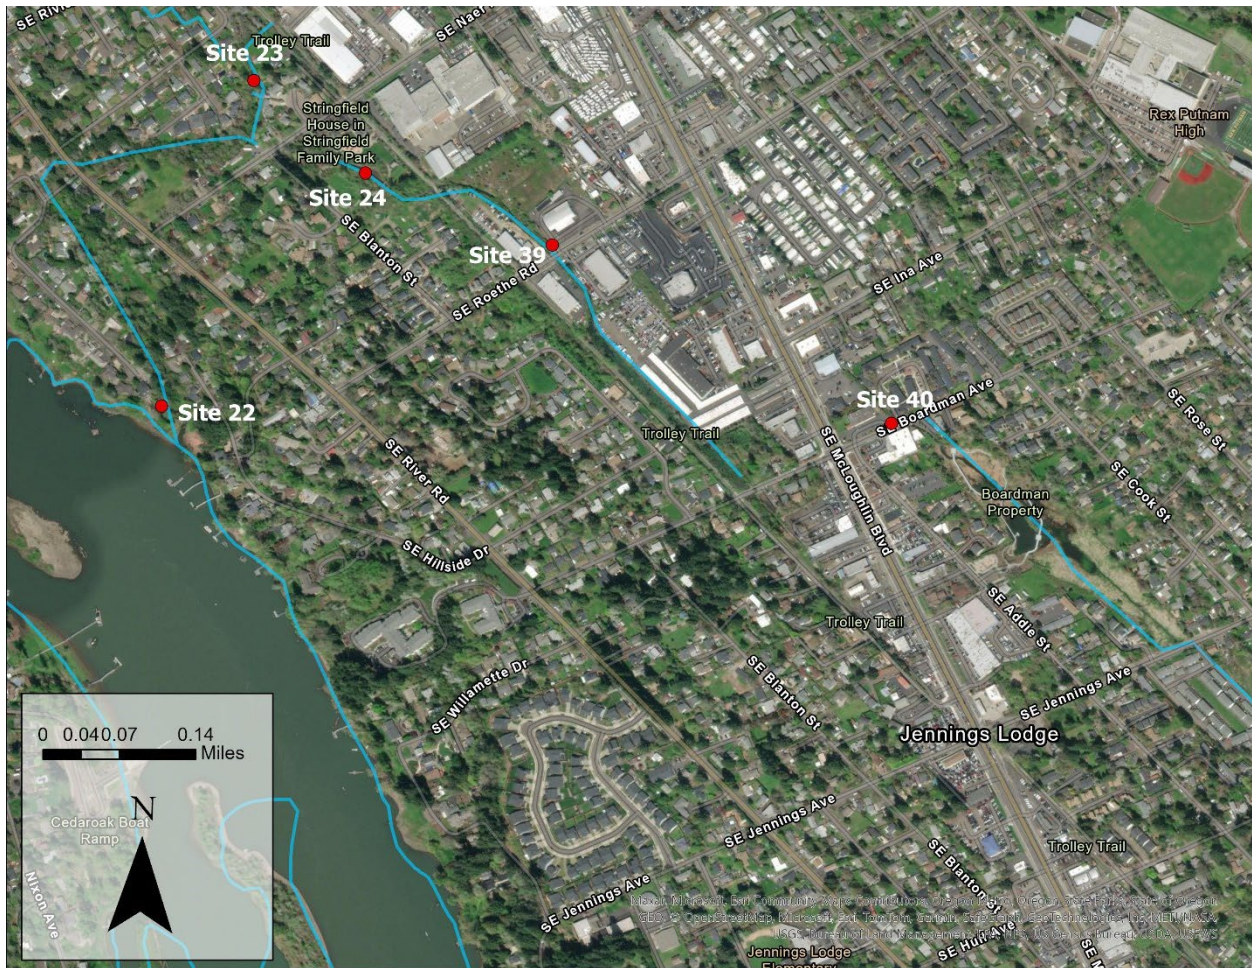
Figure 31 - Location of Boardman Creek temperature loggers.

- Site 22 – confluence of Boardman Creek with the Willamette River
- Site 23 – North Fork of Boardman Creek
- Site 24 – Boardman Creek at Stringfield Park (unretrievable)
- Site 39 – Boardman Creek at Roethe Road
- Site 40 – Boardman Creek at Boardman Avenue

Similar to last year's finding, we see that the coolest water in this watershed was recorded in the North Fork of Boardman Creek (NCWC, 2023).

- Average 7dAM at Site 22 (July -August) = 20.4 °C
- Average 7dAM at Site 23 (July -August) = 19.1 °C
- Average 7dAM at Site 39 (July -August) = 21.7 °C
- Average 7dAM at Site 40 (July -August) = 22.2 °C
